# REPAIR OF THE INVERTED GEAR RACK IN-WALL (SCHWINTEK) SLIDE-OUT SYSTEM

TSB Number:	146-001-2022		
Product:	Inverted Gear Rack In-Wall Slide-Out System manufactured between October 2021 and January 2022		
Date:	June 24, 2022	Labor Rate:	5.0 Hours Allowed (2.5 hours per side)

This document is to address the concern of the increased frequency of Schwintek slide systems becoming inoperable in the identified time frame.

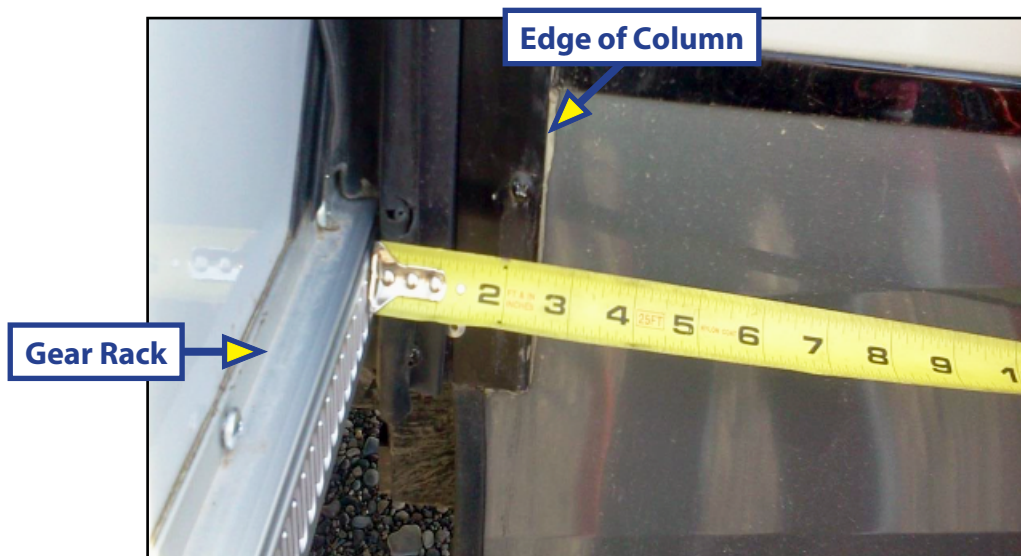
## Photos of Measurements After Completing Repair

1. Take measurements (similar to the measurement featured below) from the gear rack to the edge of the column with the tape measure pressed against the gear rack, not above or below it.
2. This measurement is best taken with the slide extended at 6 inches from the exterior of the coach and then again with the slide at full extension at all four corners for a total of eight measurements.

3. Tolerance is 2 3/8" to 2 5/8". Ideal measurement is 2 1/2".
